Wokingham Section 19 Flood Investigation

Draft Report

March 2024

**WOKINGHAM
BOROUGH COUNCIL**

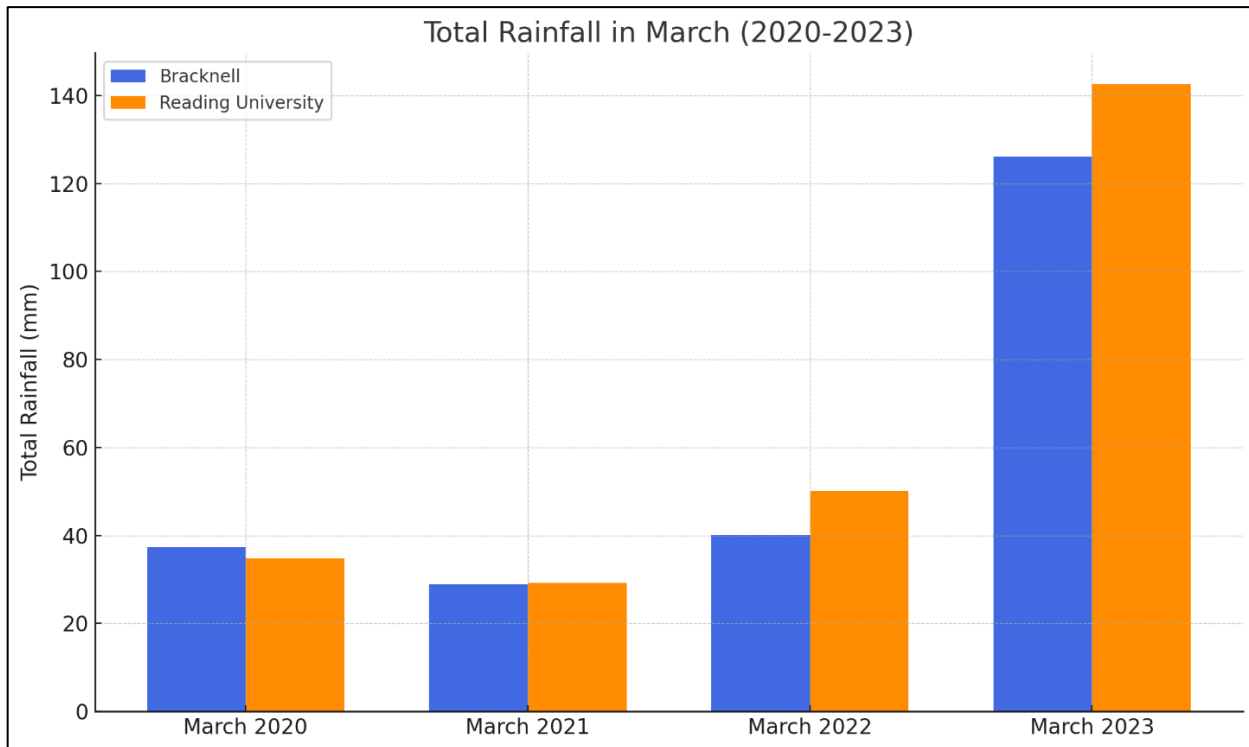
Figure 6- 2: Total rainfall recorded at both rain gauges in March 2023 and March for the preceding three years

The Environment Agency's [Hydrology data explorer service](#) indicates that amount of rain that fell during the month of March 2023 was relatively minimal, although fairly consistent. It is evident that rainfall was recorded at both the Reading University and Bracknell rain gauges, from 06 March 2023 until the storm event on 31 March 2023. Figure 6- 1 shows that the rain gauges recorded significantly greater rainfall levels in March 2023, compared to the same month for the preceding three years. Although the amount of rainfall varied throughout the month, it is likely that antecedent conditions exacerbated flooding within the borough. This is also confirmed by the information provided in the EA water report for the Thames area, which highlights high rainfall throughout the month of March, which led to saturated soils, increasing the likelihood of flooding.

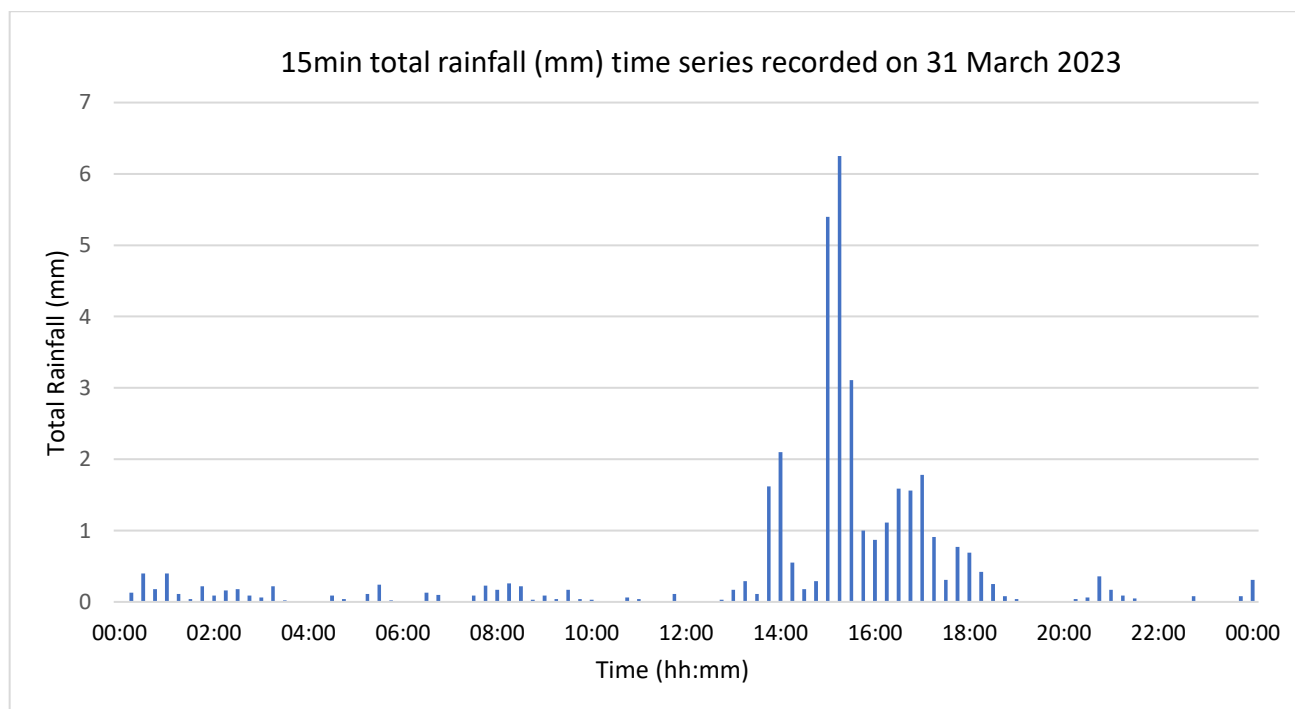
Figure 6- 3: Total rainfall on 31 March 2023 from the Bracknell gauge

The rain gauges at Bracknell and Reading University indicate that there was rainfall throughout the day of 31 March 2023 in both locations. Rainfall was relatively low and inconsistent until approximately 12:45. Although rainfall depths were low, the event was prolonged, lasting until 19:15 (6.5 hours), with the peak of the event occurring at 15:00 – 15:30. This pattern was consistent across both rain gauges.

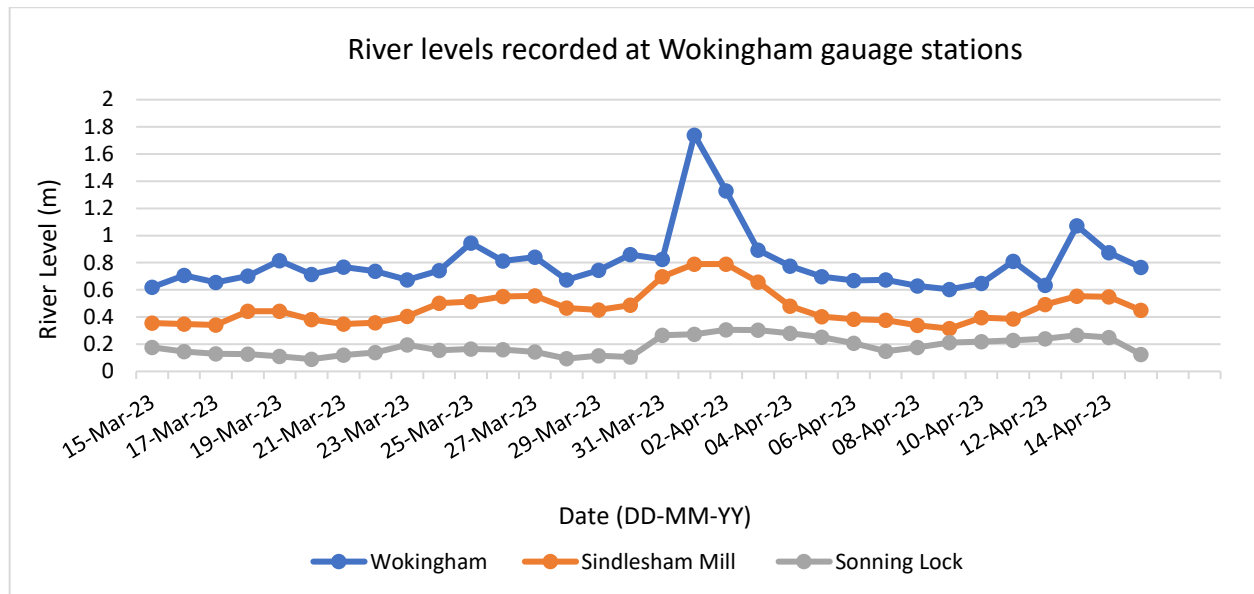
Figure 6- 5: Comparison of river level data between 15 March and 15 April 2023

Data shown in Figure 6- 3 indicates that river levels were relatively consistent between 15 March and 30 March 2023. Gauge data highlights that at all three locations, river levels peaked on 31 March or within a few days following the storm event. It is evident that the

Emm Brook in Wokingham experienced the most significant rise in water levels, reaching a daily maximum water level of 1.74m on 31 March 2023. Further analysis shows that river levels decreased to pre-event levels on approximately 04 April 2023.

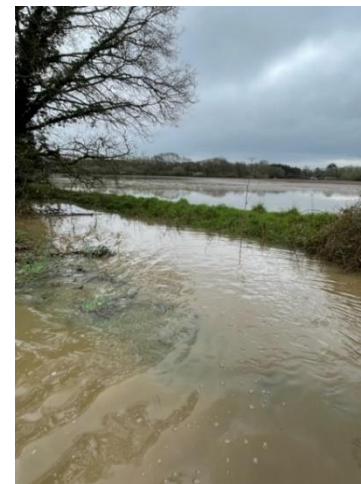
2. Flooding of ditch and field adjacent to Hogmoor Lane

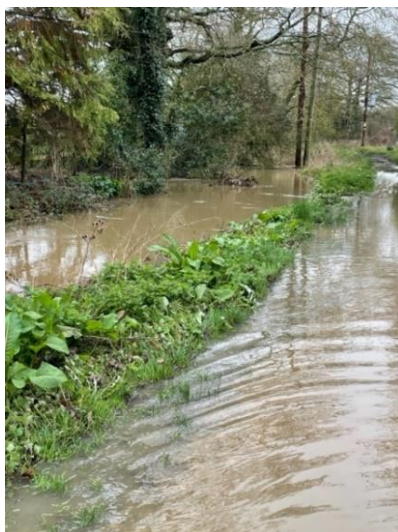
3. Flooding of Hogmoor Lane and adjacent ditch

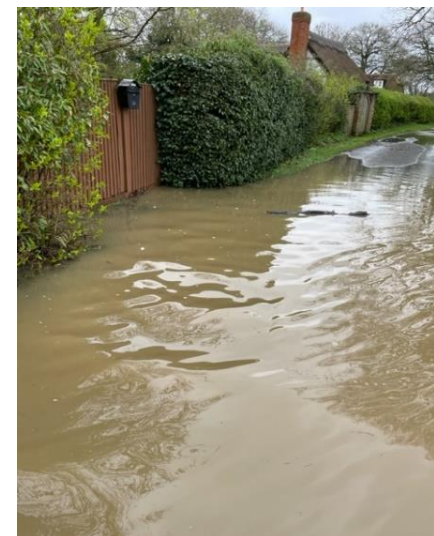
4. Surface water pooling outside property

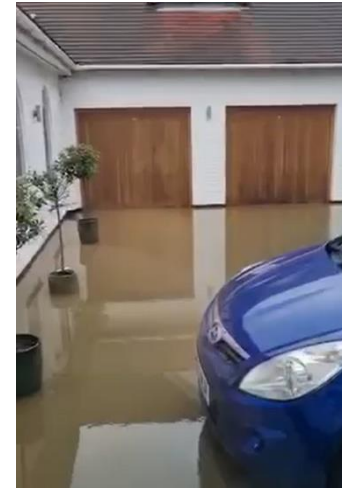
2. Flooding of driveway on 31 March 2023

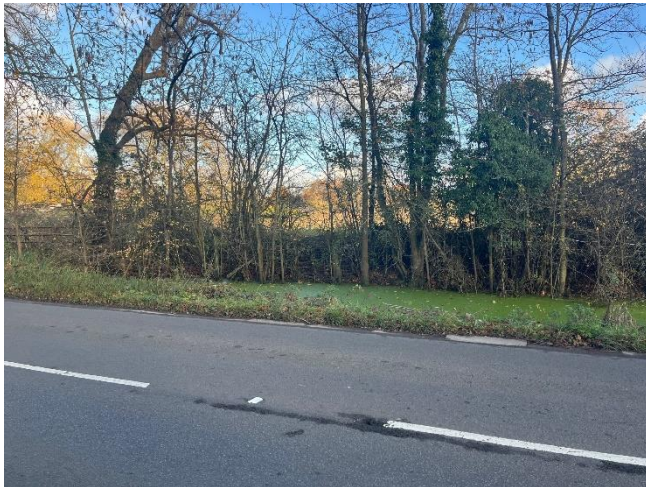
<p>3. Site visit - high water levels in ditch on east side of the property (taken on 28 November 2023)</p>	<p>4a. Site visit - blocked culvert north of the property (taken on 28 November 2023)</p>

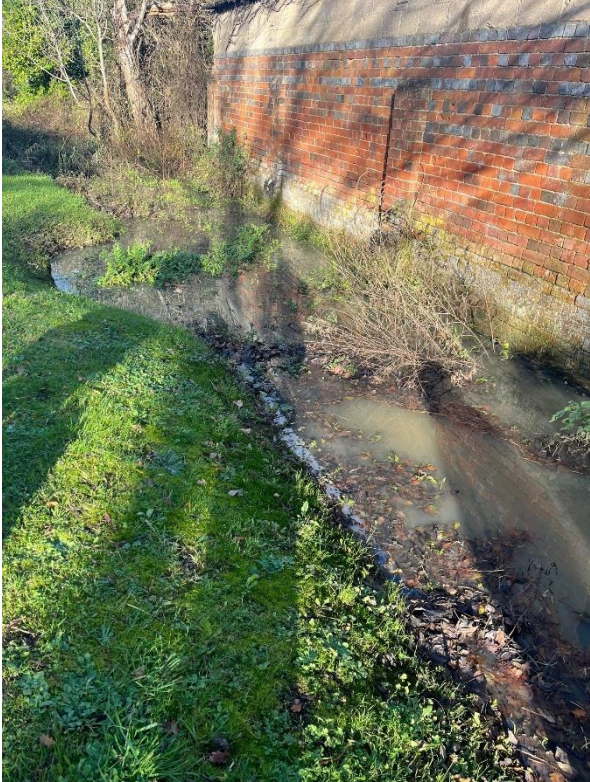
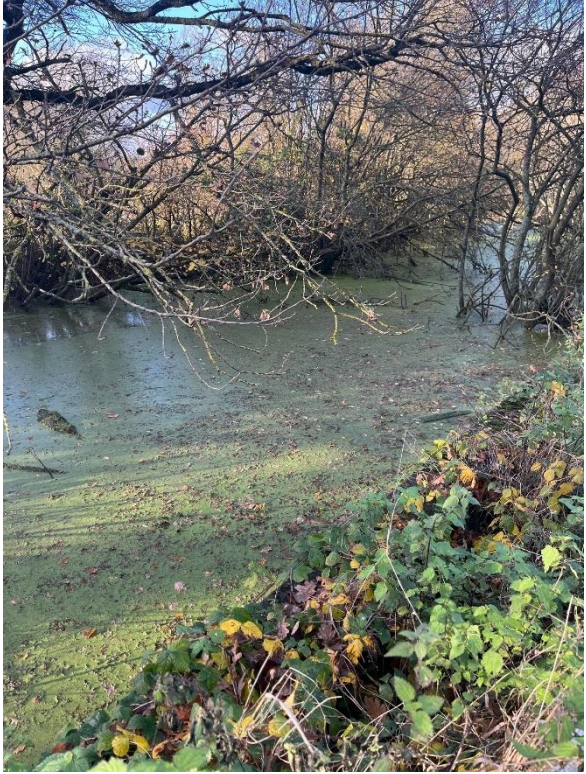
<p>4b. Site visit - ditch downstream from culvert (taken on 28 November 2023)</p>	<p>5. Site visit – ditch on western side of Wokingham Road, north of the property (taken on 28 November 2023)</p>

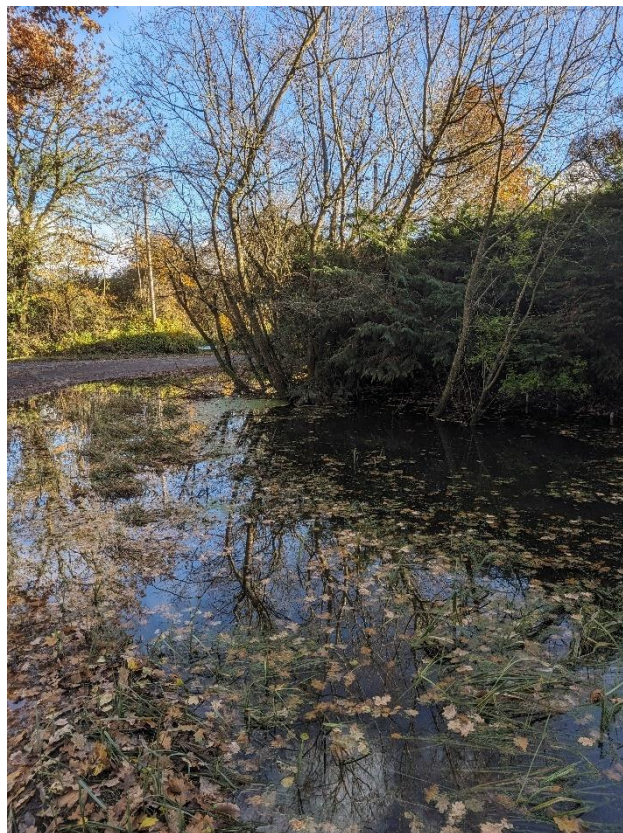
Figure 9- 2: Photographs showing presence of vegetation growth in watercourses in Hurst

This is the most important recommendation detailed in this section, as the flooding experienced in Hurst on 31 March 2023 was strongly linked to a lack of capacity along main river and ordinary watercourse systems, due to the presence of debris or heavy vegetation growth, as shown in Figure 9- 1. Therefore, taking preventative measures towards managing vegetation and debris along the watercourses is a key priority, to prevent a similar event happening in the future.

It is recommended that Wokingham Borough Council as LLFA, identify riparian owners in Hurst and advise of riparian responsibilities. The Environment Agency, in partnership with the riparian owners, should consider an enhanced maintenance schedule for the extensive watercourse systems within the parish.

It is recommended that residents, WBC as LLFA works in partnership with the EA and local residents to develop a riparian maintenance plan, and ensure that riparian awareness is acknowledged and understood.

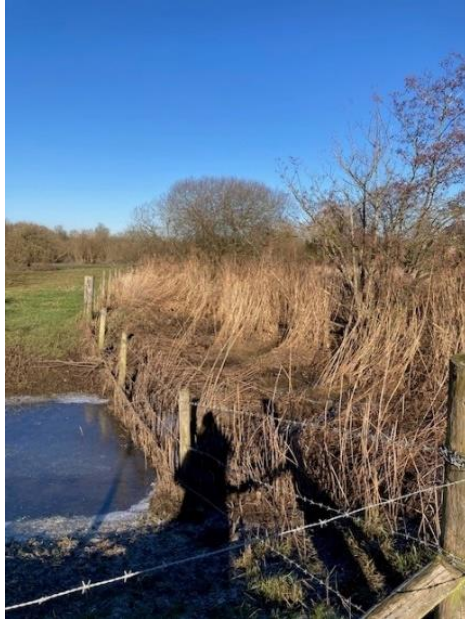
Twyford Brook severely restricted (January 2024)

One of the suggestions of the report prepared by landowners is the importance of maintaining flow in the Twyford Brook. The report recommends that all obstructions within the Twyford Brook, especially from the A321 (Hurst Road) bridge to Twyford station, to prevent water backing up towards Hurst should be cleared. This Section 19 reiterates the importance of this as the Twyford Brook will play a key role in allowing flows from watercourses upstream to be discharged.

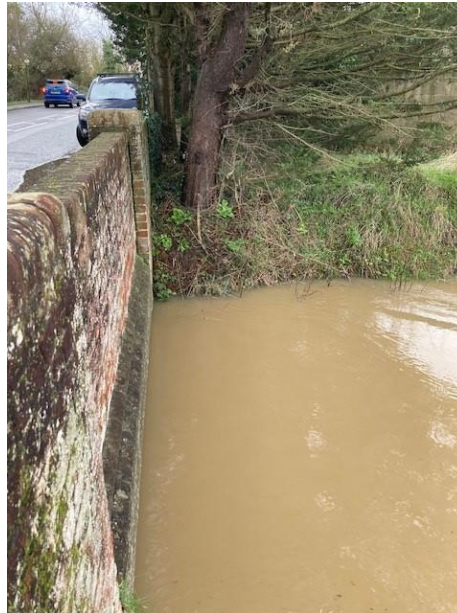
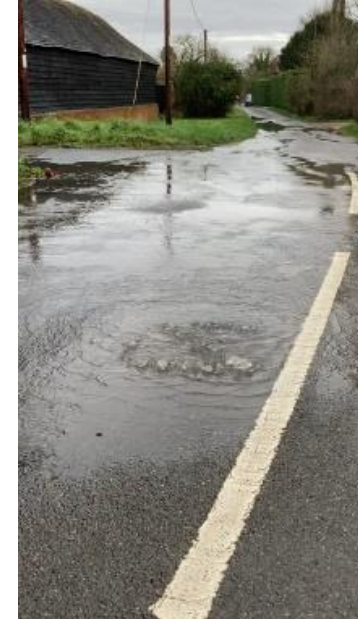
Thames Water pumping station ineffective

4. **Thames Water:** It is widely recognised that Thames Water's pumping station is woefully inadequate for the job, resulting in drains overflowing and adding to the flooding issues in Hurst. Therefore, WBC should deal with Thames Water to find a resolution for this problem.

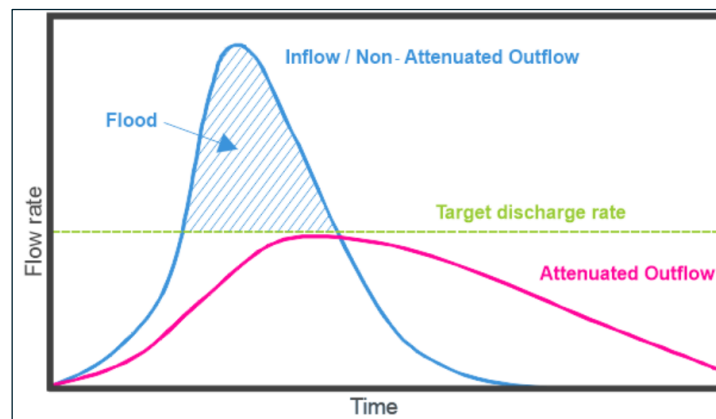
Attenuation at Stanlake and Haines Hill, requiring agreement to flood their land at times of intense rainfall, to slow the water reaching Hurst
